Riparian Assessment of the Callander Bay Watershed

By Tim Martens
A Sense of Place Consulting
December 31, 2012

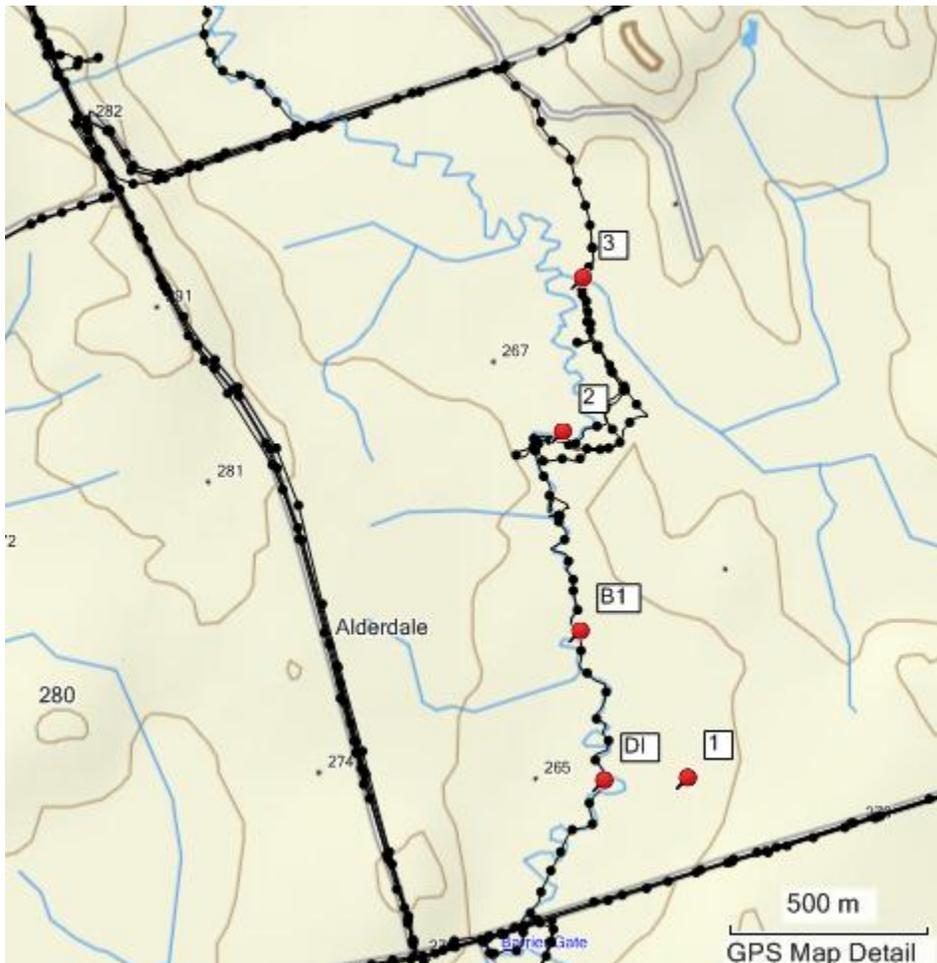
12-1

Graham Creek was accessed by canoe from Chiswick line, just east of Alderdale Road. Tile drainage (located at D1) was found to be entering into the creek only meters from its bank, creating an erosive channel. Photographs were taken at locations D1 and 1. A beaver dam was located at location B1. At location 2, there was no way of continuing due to the thickness of the alders. Signs of cattle grazing and excrement were found at the waters edge near location 2, and near location 3 at the confluence of another creek that enters into Graham Creek from the southeast.

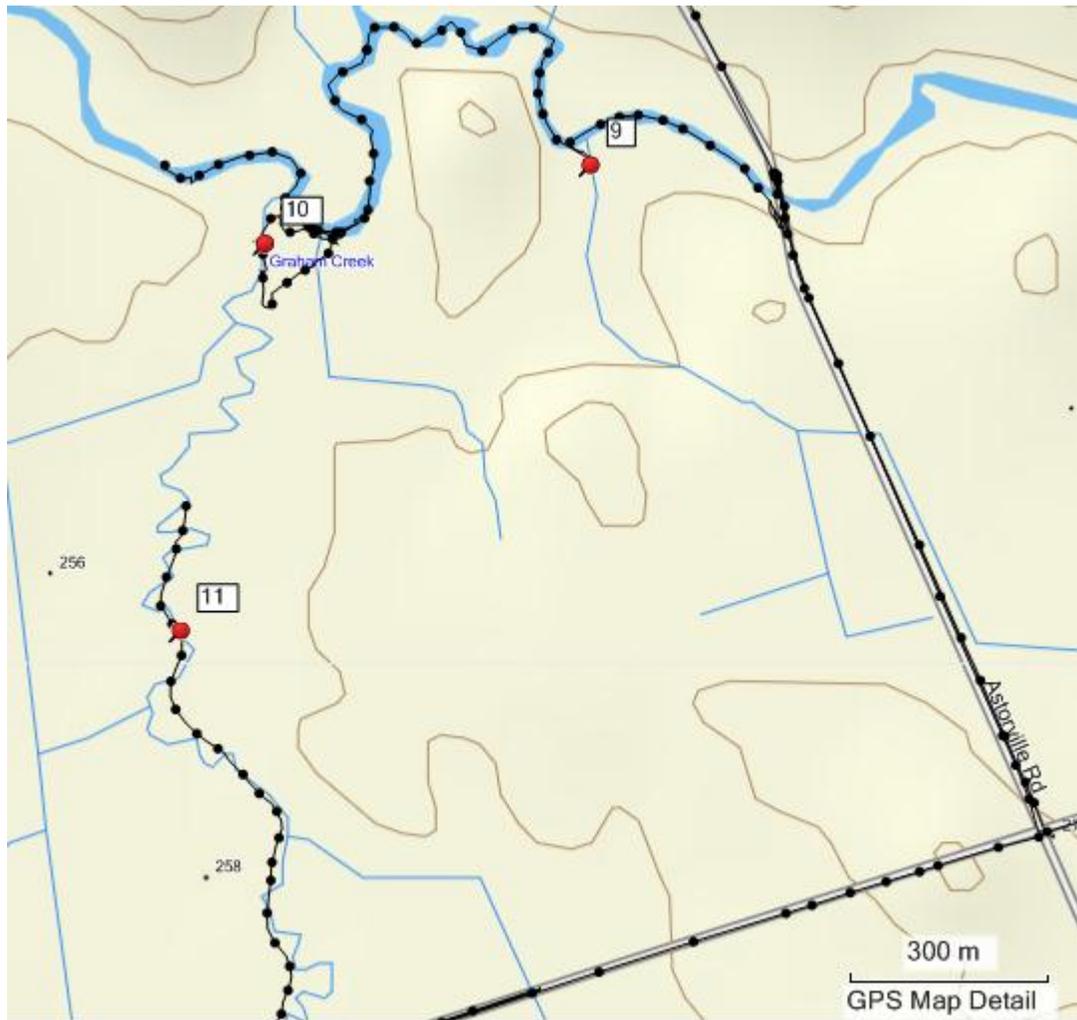
Oct 23-1

Access to Graham Creek was gained from the Wasi River at Astorville Road. Travelling up the creek from its mouth, a home-made bridge was found on a first order creek at location 9 with some erosion. At location 10, there was evidence of cattle grazing and excrement at the mouth of Graham Creek. At location 11, some of the most significant erosion was seen with steep-sided banks completely denuded of vegetation and with no buffer of any kind along the field above the embankment. The canoe was taken out at River Road.

Proper fencing to keep livestock out of the creek and re-establishment of native vegetation along the banks will help to reduce direct and indirect sources of phosphorus from entering the water column.

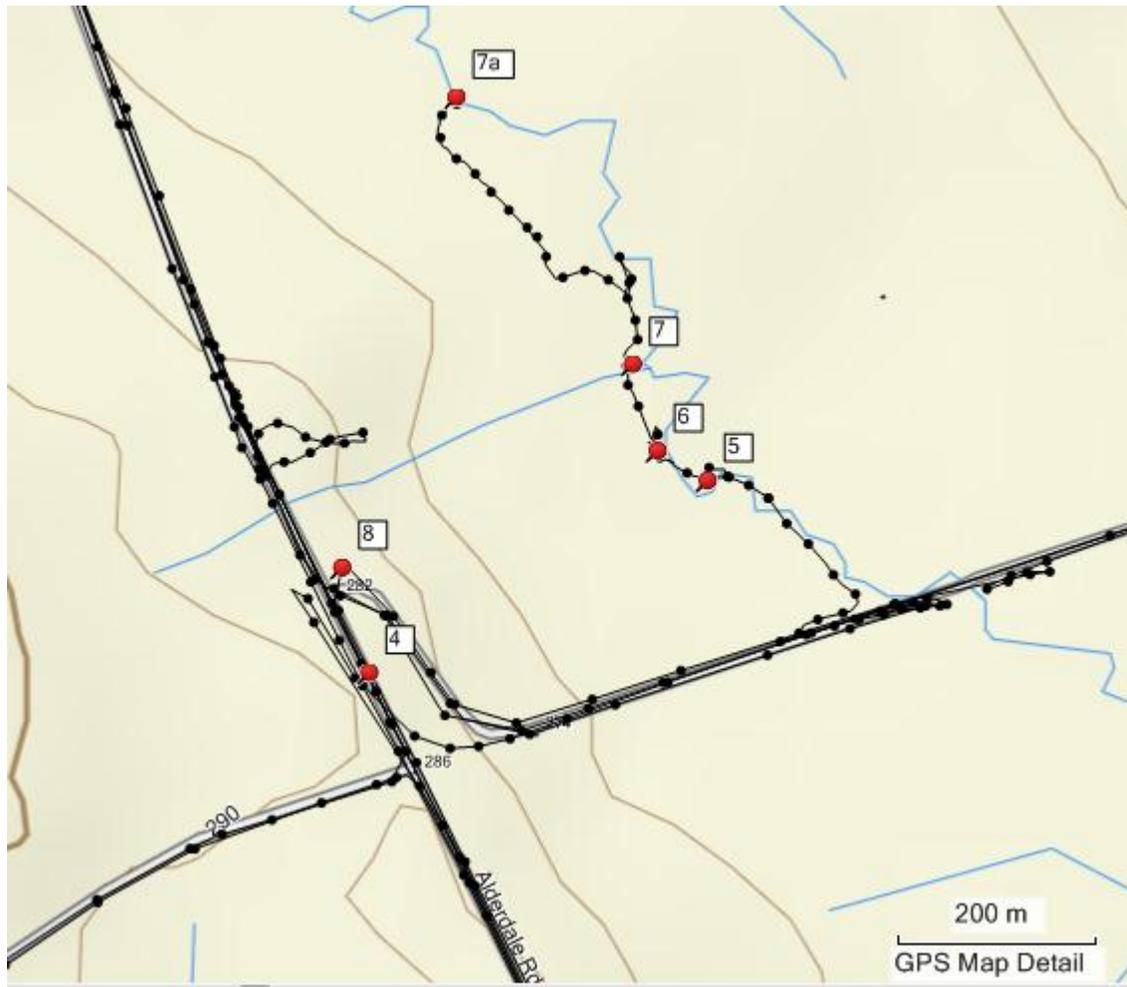
Oct 23-2

Photos were taken at location 4, where nutrient saturated water was running from a horse paddock along Alderdale Road. Two hundred meters north from this runoff, a culvert channels water across the road to the east, eventually joining Graham Creek at location 7. There was no distinct channel from the road as the water naturally fans out over the forest floor. At location 8, the municipality has been dumping organic material from ongoing dredging along Memorial Park Road. There was no evidence that any of this loose material is making its way into Graham Creek. There was erosion from cattle grazing at location 5, and tile drainage at location 6. At location 7a, proper fencing was in place to keep the cattle out of the creek, leaving the bank in much better condition than at location 5.

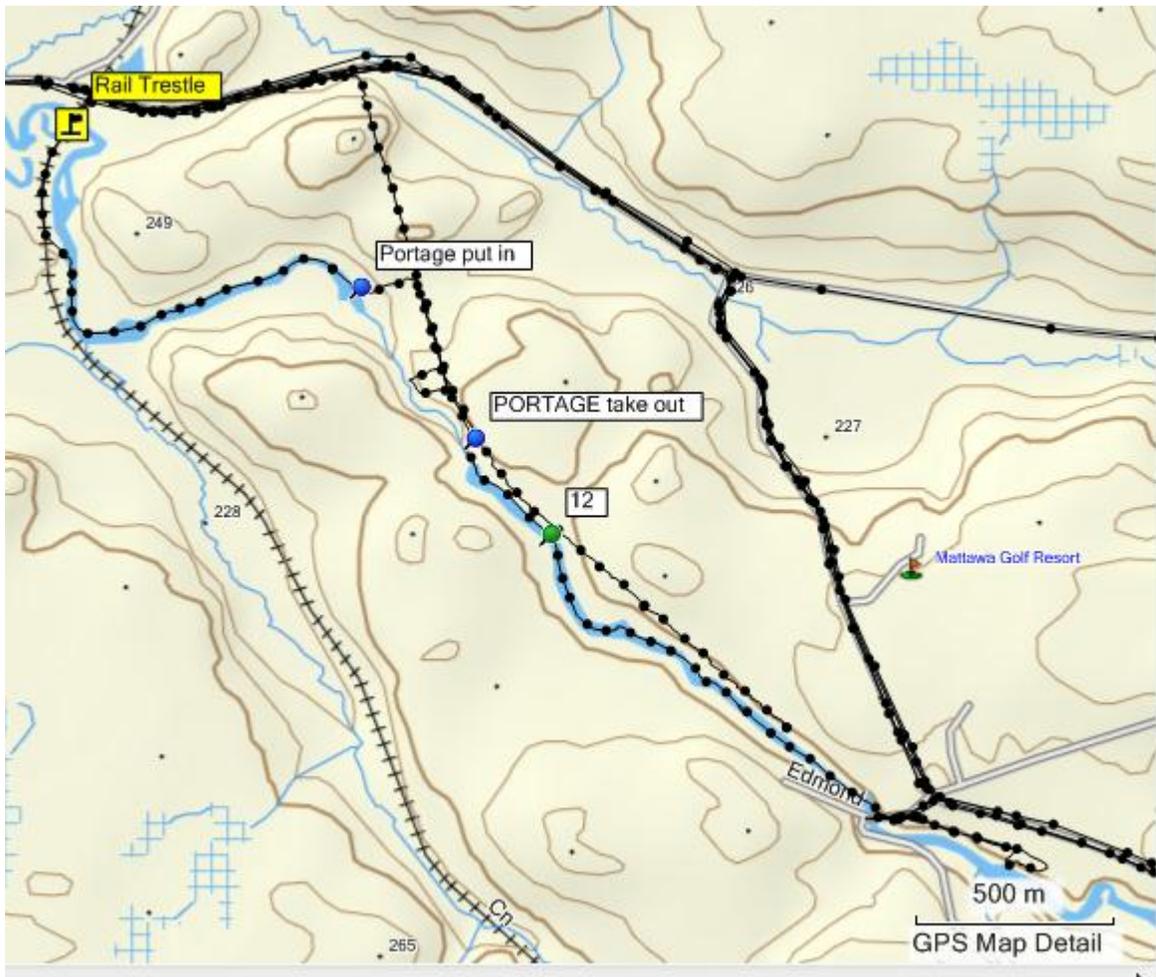
Oct 23-3

This section of the Wasi River was accessed by canoe from the Edmond Street bridge. The banks of this section of the river appeared fairly natural and had good tree cover. At location 12, several pictures show the river following the abandoned rail line. A significant series of rapids was portaged by following part of the old abandoned rail line. No degradation of the river banks could be found between Edmond Street and the rail trestle at Wasi Road.

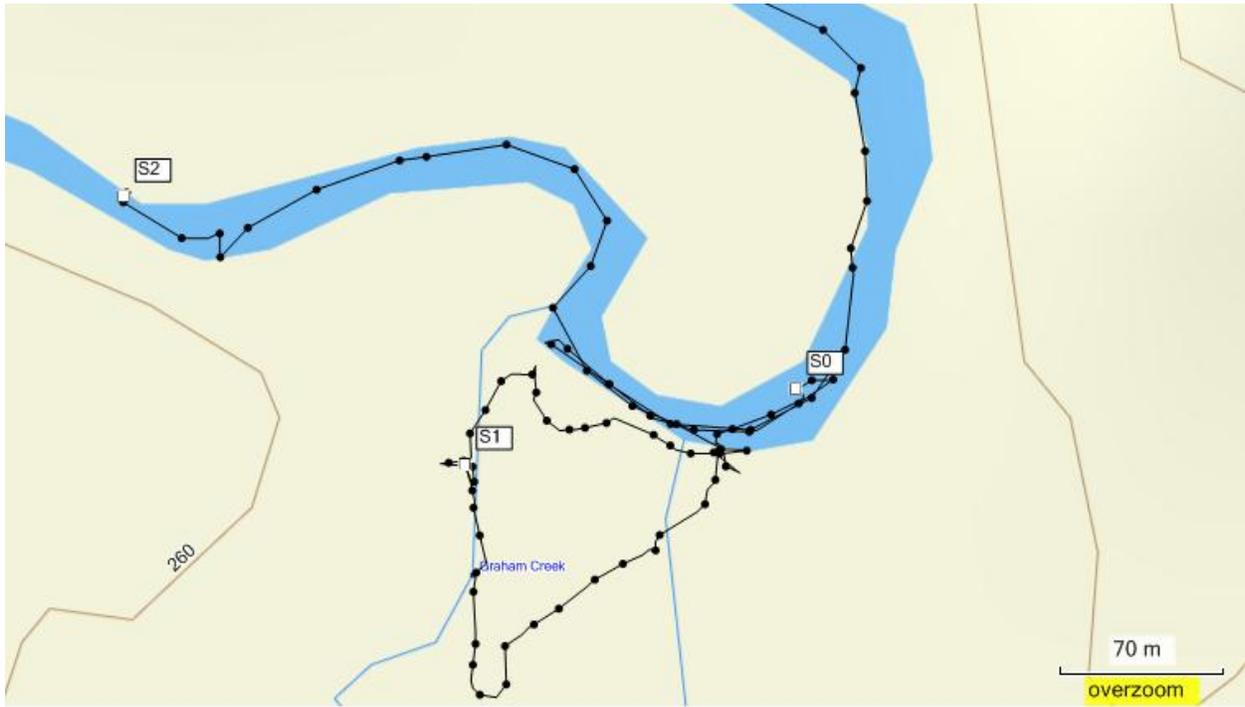
Oct 23-sampling locations

These sample sites follow the point sequence as requested in the excel spreadsheet file sent to me Oct.19, 2012. (Sample_sites_along_Wasi_R_fall_2012.xlsx). Results from these samples show a significant rise in the Total Phosphorus at location S2, just downstream of the confluence of Graham Creek and the Wasi River.

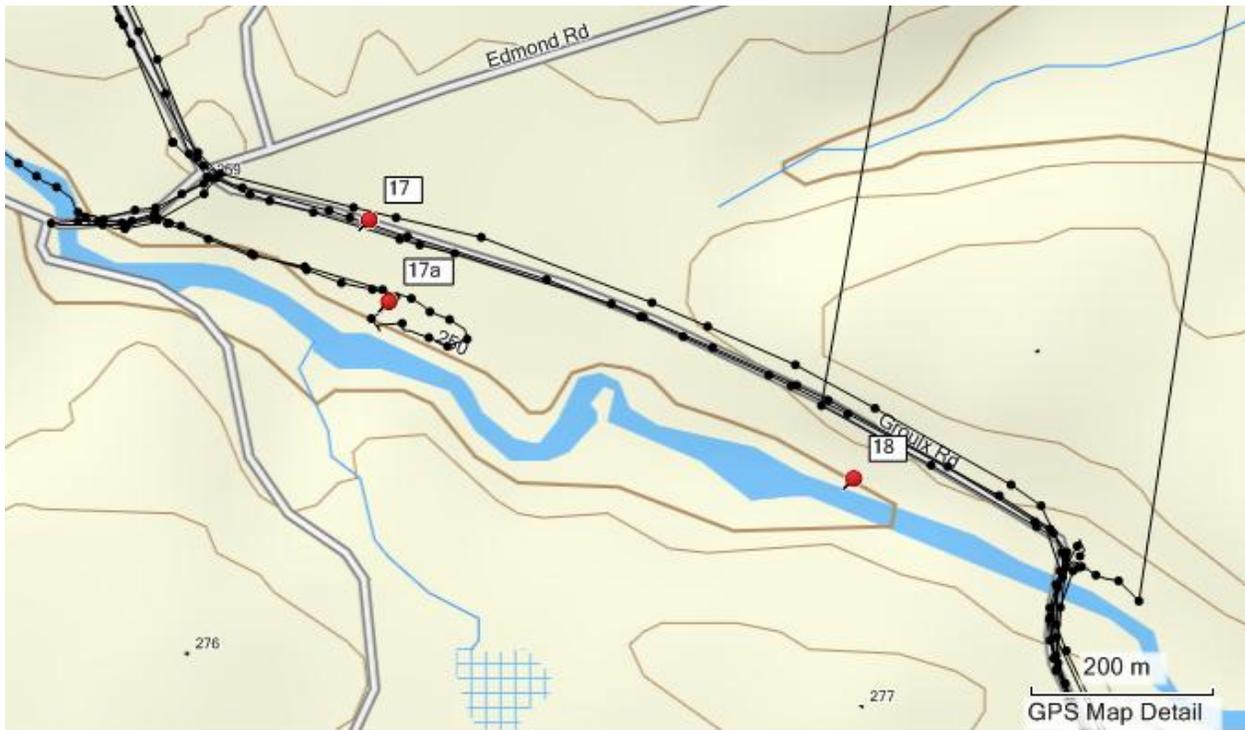
Nov. 2-1

At location 17, photos were taken of a significant cattail marsh buffering the runoff from the sheep farm to the north before flowing under the railway line and into the Wasi River. There was no sign of nutrient rich water coming from the farm at this time. At location 18, photos were taken of the forest on the south side of the Wasi River where it appeared that cattle have been grazing in the woodlot. Across the bridge to the east, this same woodlot was fenced and showed signs of grazing in the past.

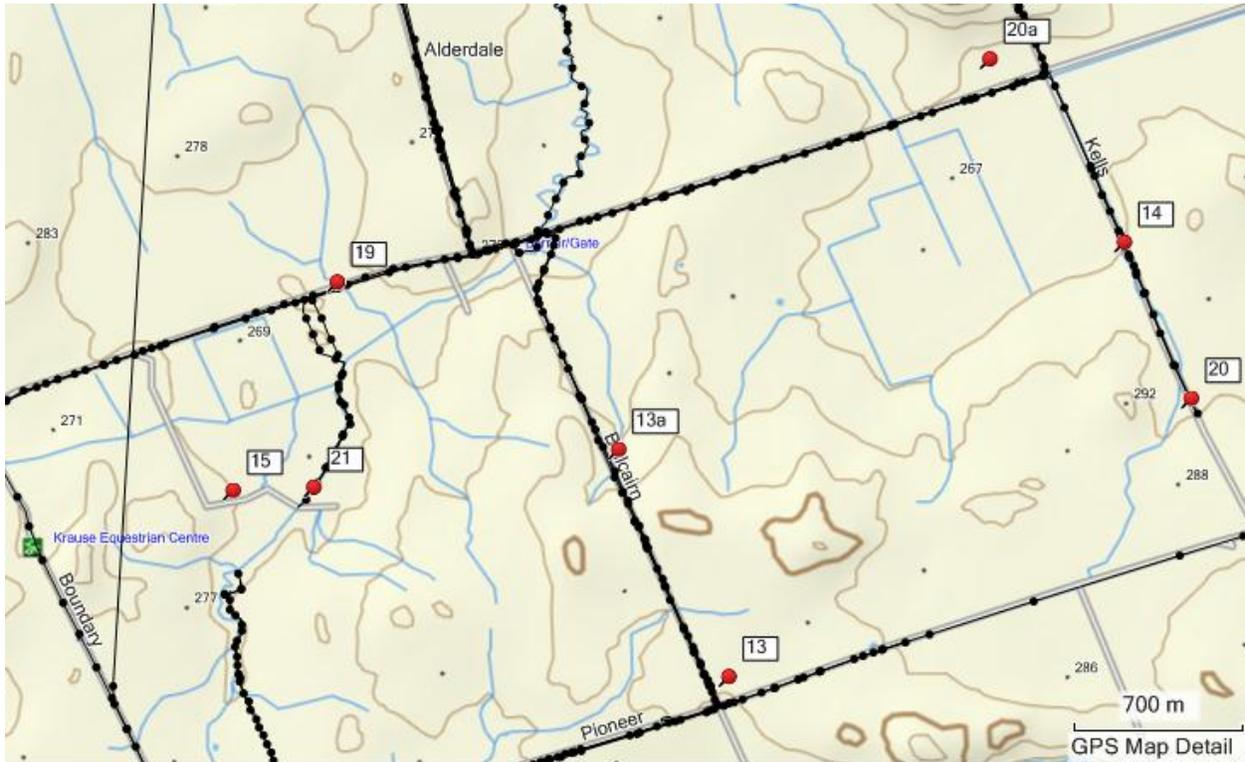
Nov 2-2

From Memorial Park Drive, Graham Creek was channelized south toward location 19, and appeared well vegetated for most of its reach. At location 19 on Chiswick Line, looking northwest, there was recent clearing of vegetative cover (alders) close to Graham Creek (photos 9-10). No significant erosion can be seen along Graham Creek to the south of Chiswick Line up to location 21. At location 13, at the corner of Pioneer Road and Belcain Road, there were cows walking in open surface water at this point. This appears to be surface water with no significant flow in any direction from here. At location 13a, photo (16) shows dairy cattle on the farm occupying Belcain Road and Chiswick Line to the north. It was difficult to determine whether there was fencing keeping cattle out of the creeks from any vantage point. On Kells Road, between Pioneer Road and Chiswick Line, an unnamed creek that joins Graham Creek comes close to the road at location 20. Beef cattle were seen up stream of location 20 to the southwest. There was lots of evidence that cattle have been in the water further along Kells Road at location 14, where this unnamed creek comes down onto the floodplain. At this point, there was pooling of the unnamed creek (photos 17-18) where the cattle have been grazing in the black ashes and red maples. Behind the farm at location 15, there was a large effluent containment tank and beef cattle in the bush lot behind. This was investigated from the south on Nov 14 (map Nov 14-1).

It would be wise to determine how the containment of wash water and manure is handled on the dairy cattle operation on the corner of Belcain Road and Kells Road. Proper fencing to keep livestock out of the creek and re-establishment of native vegetation along the banks will help to reduce direct and indirect sources of phosphorus from entering the water column.

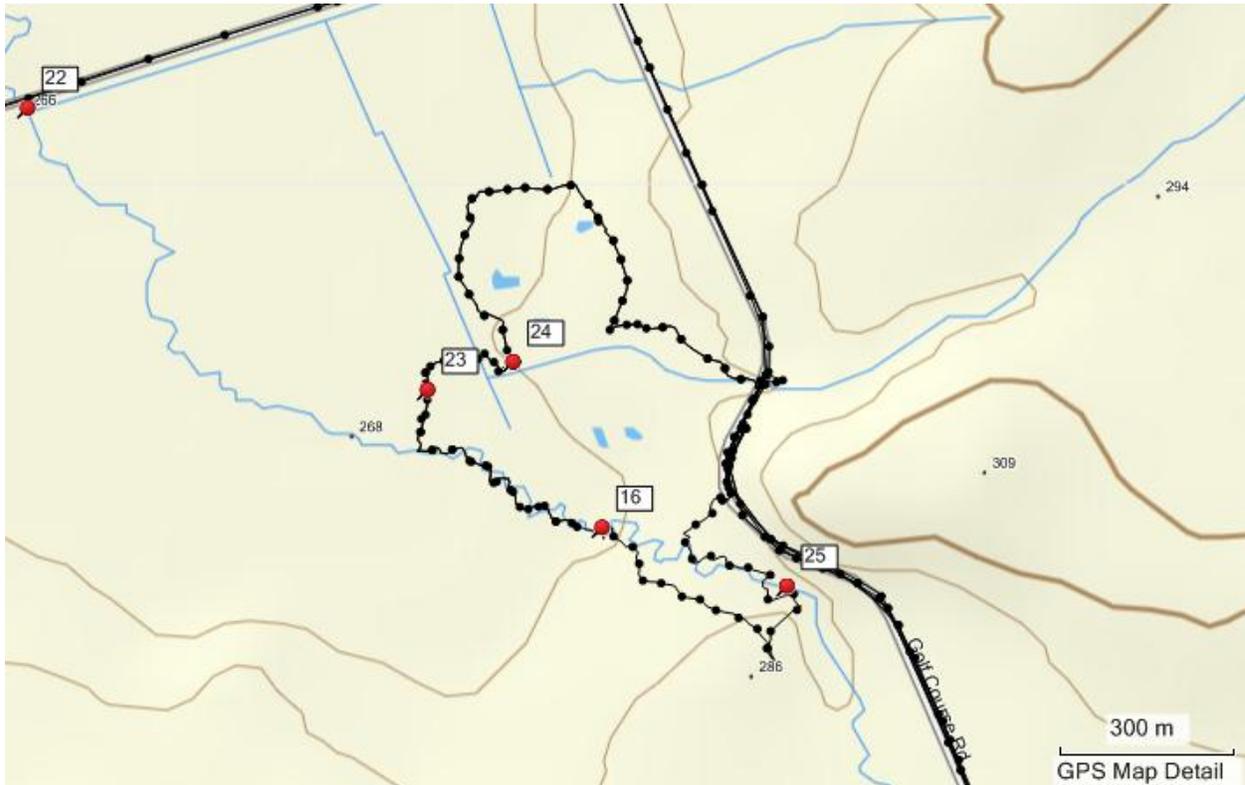
Nov 2-3

Chiswick Creek was entered from Golf Course Road, just south of Clear Springs Golf Course. Before Chiswick Creek entered the golf course, there was a very natural series of waterfalls, rapids and well vegetated sections at location 25. At location 16, Chiswick Creek is only vegetated by grass, completely devoid of other natural vegetative cover, and mowed right up to the edge of the water. Another creek that joins Chiswick Creek across the golf course from the east, is naturally vegetated before the culvert at Golf Course Road. Once on the golf course though, this creek has been straightened and vegetated in a similar fashion as Chiswick Creek. There doesn't appear to be any erosion along any of these sections.

A natural vegetative buffer should be encouraged to create a natural break along these grassed sections of creek, to reduce the amount of inorganic phosphorus entering the watercourse directly. This would also encourage stability at the bank/water interface and reduce the chance that soil born phosphorus enters the water environment during the spring freshet.

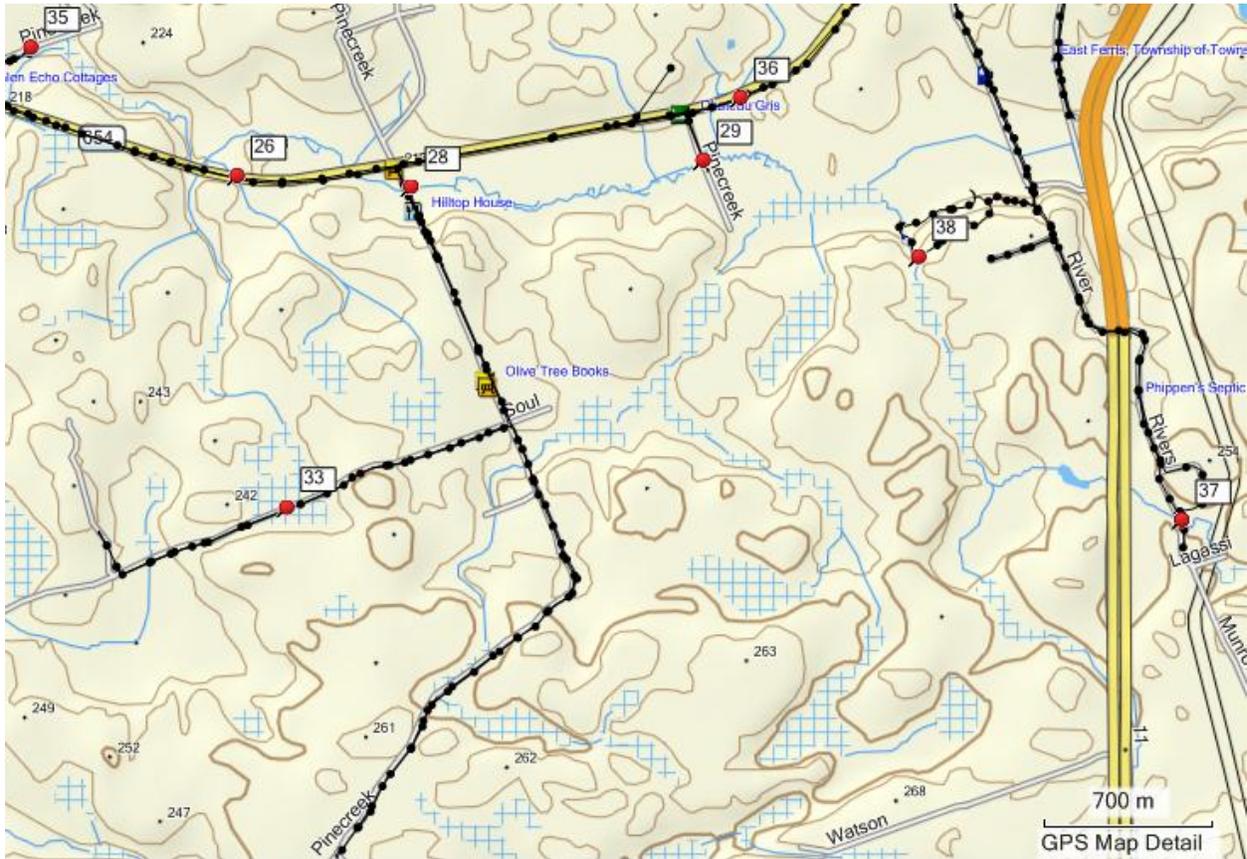
Nov 8-1

Windsor Creek at location 29, flows across a private driveway and was well vegetated on both banks. At location 38, Windsor Creek comes down off of the highlands where there was no evidence of erosion of any kind. From location 36, cows and sheep were seen to the north, but, it was difficult to tell if they were properly fenced from the creek or if there was enough of a buffer on each bank. At location 28, where a new culvert was installed, there was erosion downstream. More investigation of the interior upland of Windsor Creek, east and west of Pinecreek Road South was conducted on December 12, 2012 (see map Dec 12-1 and waypoints 66-71). At location 35, horses can be seen in the field through the gate to the east, where Windsor Creek is located. This field at location 35, was accessed from the east on December 3, 2012 (see Dec 3-1). Windsor Creek was also checked further upstream, at Rivers Road and location 37, where there was good vegetative cover on both banks before and after crossing highway 11.

Proper fencing to keep livestock out of the creek and re-establishment of native vegetation along the banks will help to relieve direct and indirect sources of phosphorus from entering the water column.

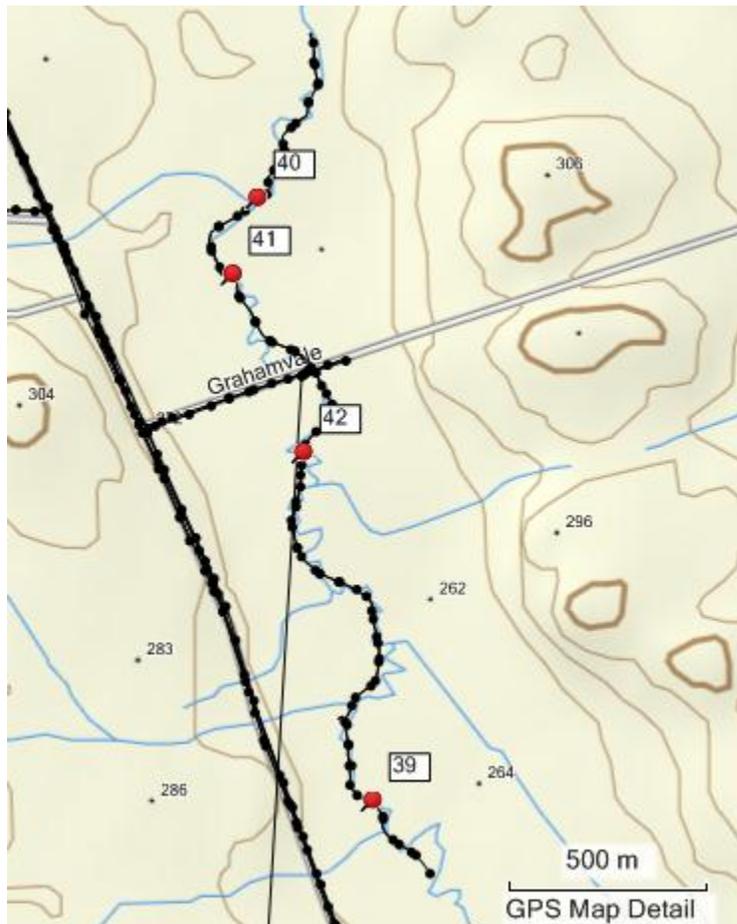
Nov 8-2

South of Grahamvale Road, Graham Creek looked very well vegetated on both banks at location 42. At location 39, cattle were clearly grazing at the edge of the creek and in the adjoining forest. This is the same property where grazing in Graham Creek was seen from Memorial Park Drive to the south. To the north of Grahamvale Road, Graham Creek was well fenced from the horses. There are beaver dams at locations 40 and 41. At location 41, though, where the difference in height of the water level from upstream to downstream was more than a meter, there was significant erosion around both edges of the dam where the water was racing through and eroding the fields on both sides.

Proper fencing to keep livestock out of the creek and re-establishment of native vegetation along the banks will help to relieve direct and indirect sources of phosphorus from entering the water column.

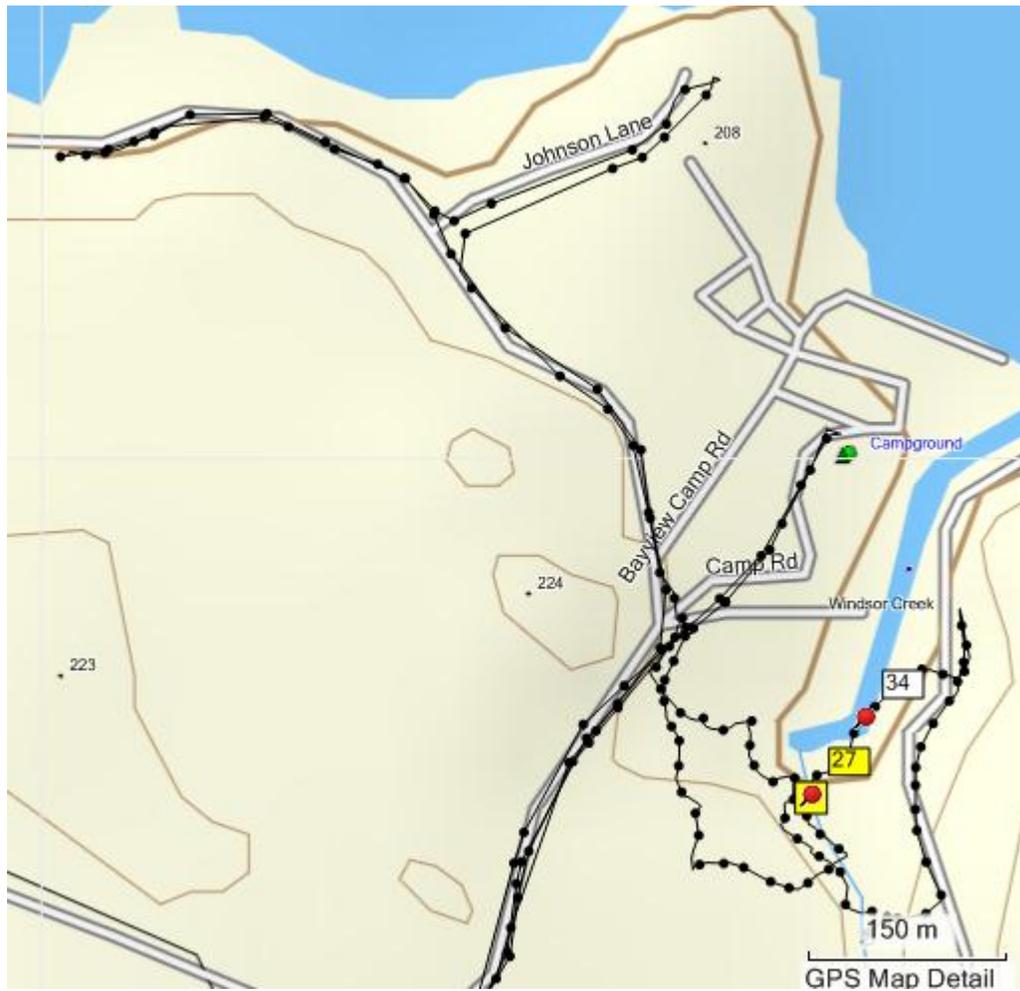
Nov 8-3

Windsor Creek was entered near Bayview Camp Road in order to access the mouth of Windsor Creek and check the channel at this point. Windsor Creek was well vegetated in this reach between location 27, and the mouth where it enters Callander Bay. There are some old structures (docks) along the channel close to the lake, but, no significant erosion.

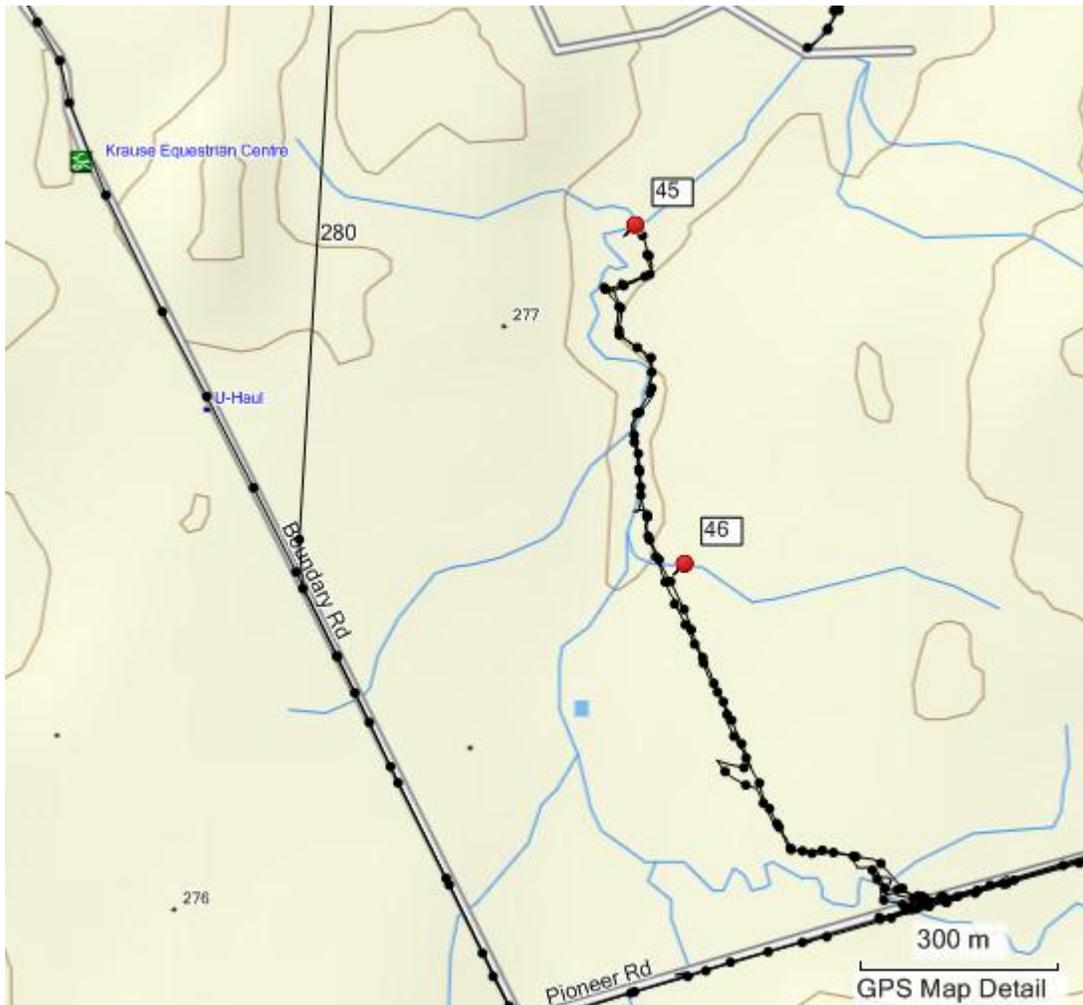
Nov 14-1

Graham Creek was accessed on foot from Pioneer Road. At location 46, the map shows a creek where tile drainage has caused erosion at the edge of the field and entering Graham Creek. At location 45, it was difficult to tell if the beef cattle are in the creek to the west. Directly across the stream from location 45, where an unnamed creek enters Graham Creek from a cattle and horse paddock to the west, a large amount of organic material and rip rap has been dumped recently.

Further inspection is required to determine if there is severe erosion occurring where this unnamed creek enters Graham Creek at location 45.

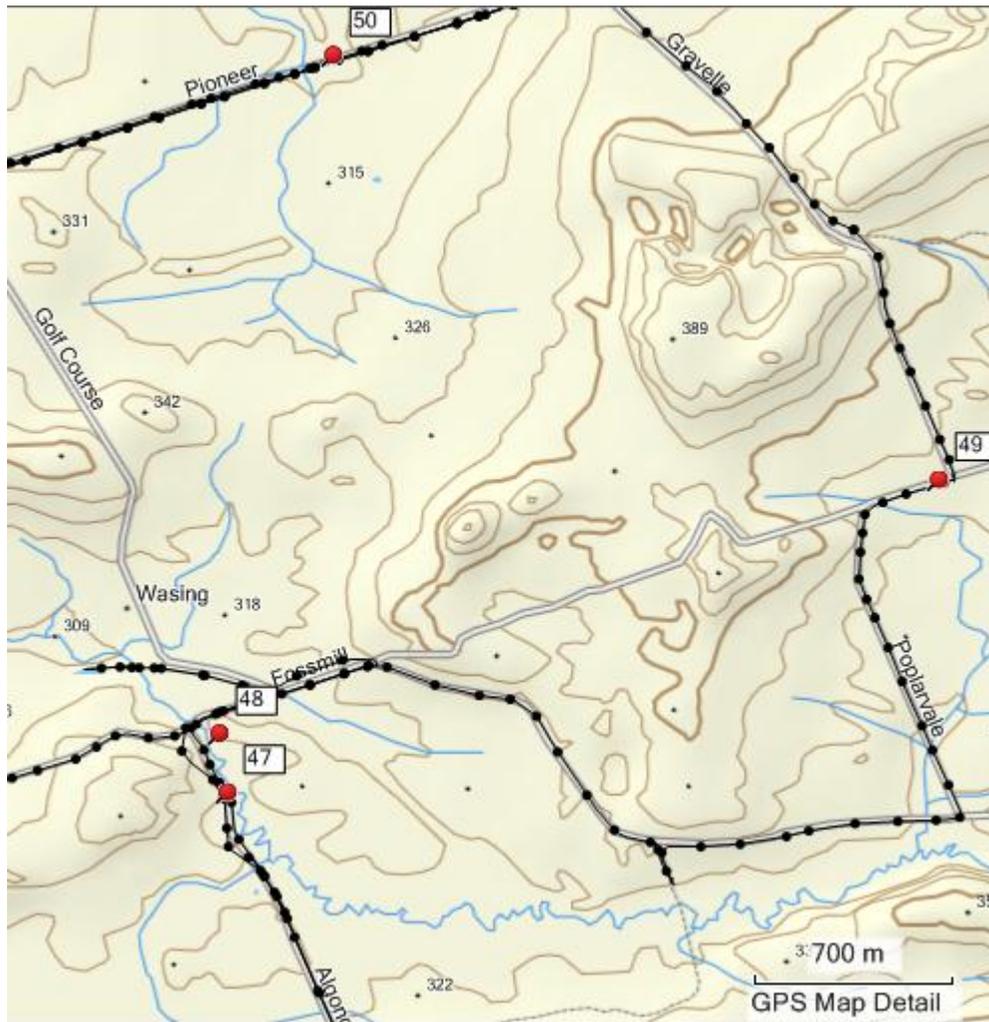
Nov 14-2

The Wasi River was fenced from the beef cattle at location 47, along Algonquin Road. At location 49, looking south along Poplarvale Road, a tractor was spreading manure onto the field (photos 4-5). Photographs taken from Pioneer Road at location 50, show a field grazed on one side and not on the other (Photo 6).

Manure management (application) techniques that minimize nutrient runoff should be encouraged.

Further investigation of the cattle containment and waste management practises in place on the farm where grazing animals are present to the south of location 50.

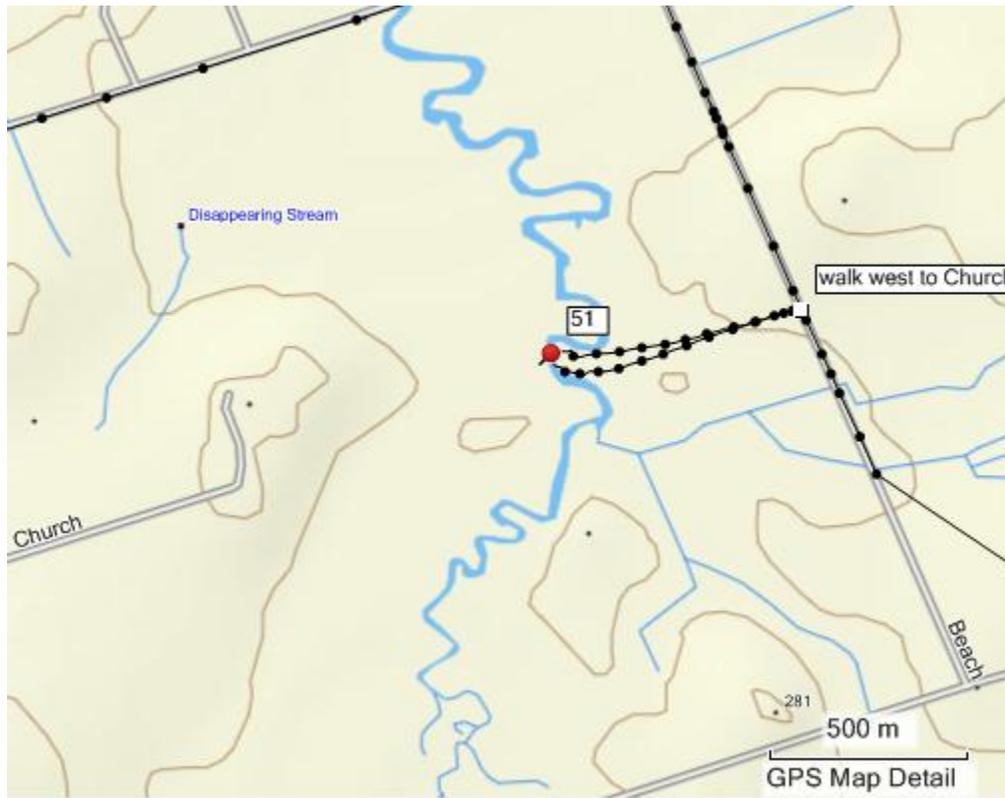
Nov 14-3

Significant grazing and associated erosion was seen at location 51, on the west bank of the Wasi River. This was accessed from Beach Road to the east.

Proper fencing to keep livestock out of the creek and re-establishment of native vegetation along the banks will help to keep direct and indirect sources of phosphorus from entering the water column.

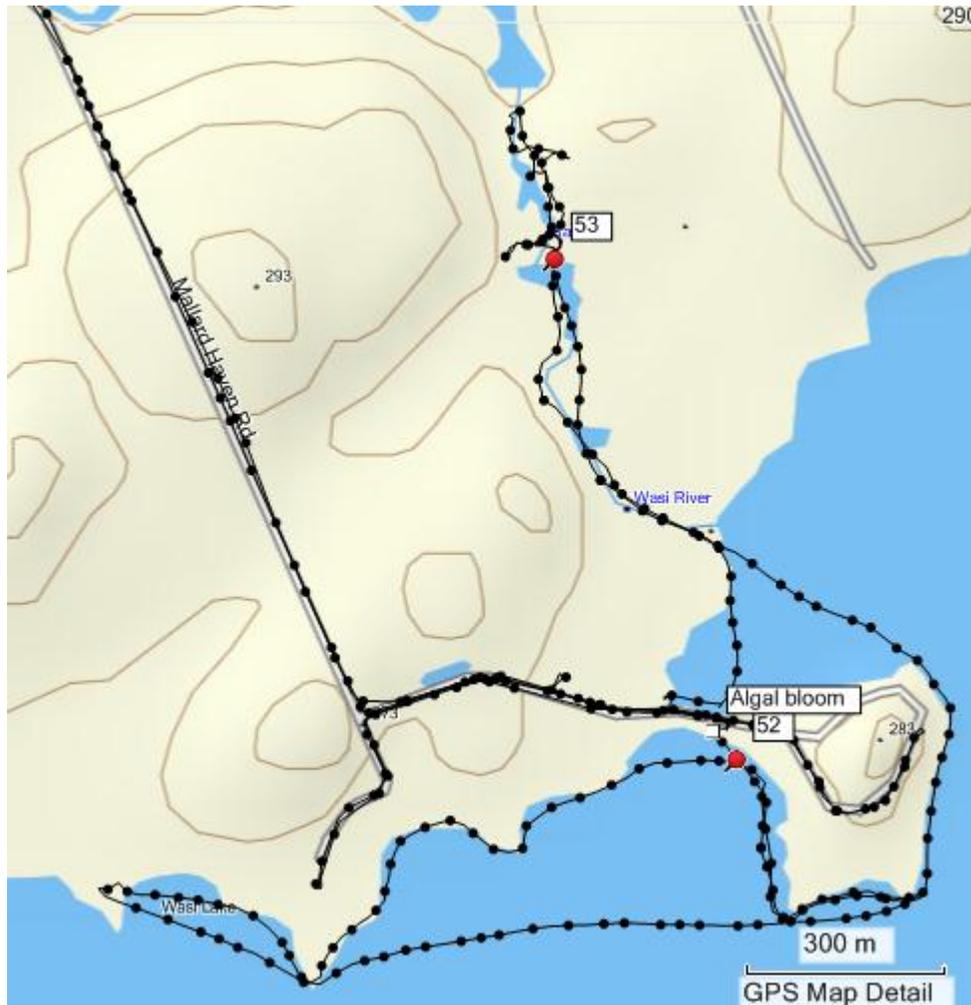
Nov 14-4

A canoe was used to access waterfront properties on Wasi Lake where significant algal blooms could be seen on Google Earth. No obvious cause for the algal blooms was seen along the shoreline. The Wasi River downstream was investigated by canoe up to location 53, then, searched on foot as far as a farm bridge to the north. There was no significant sign of erosion or problems along this stretch of shoreline.

It might be useful to check the river banks between the bridge and River Road since there is a farm property off of Mallard Haven Road, and to monitor private waste treatment systems using this shoreline.

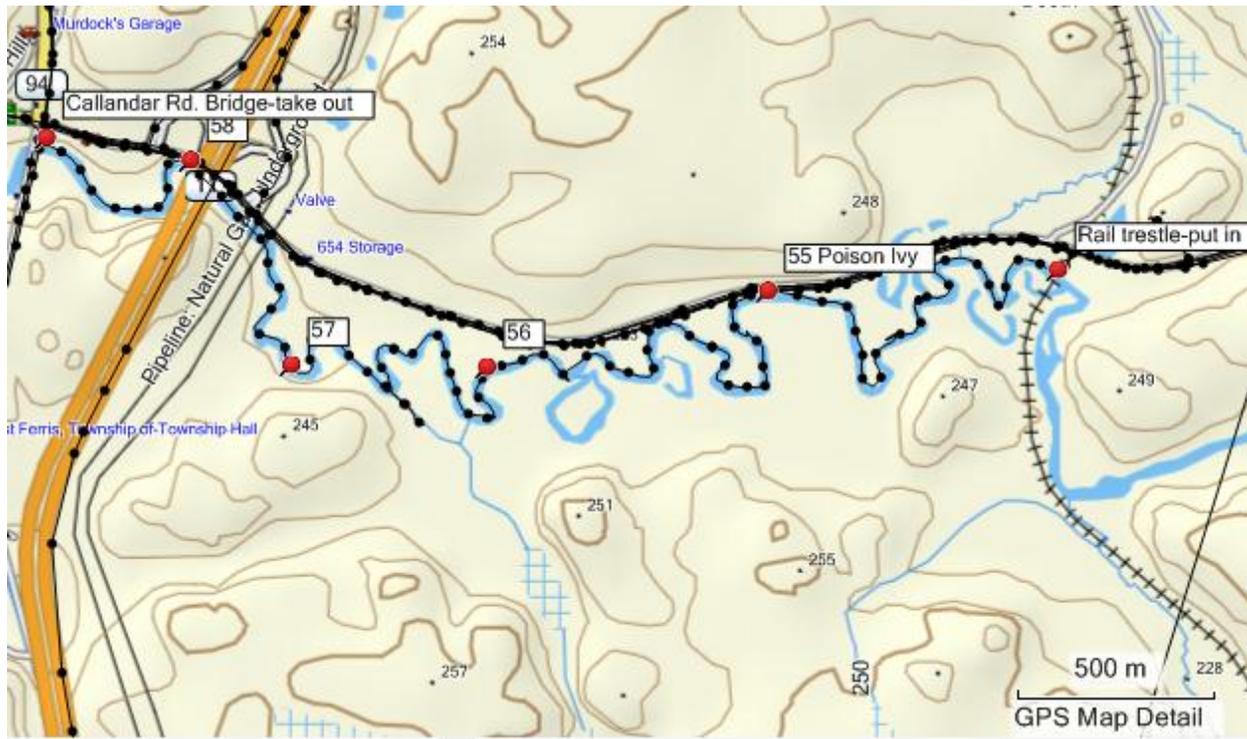
Nov 15-1

Putting the canoe in at the rail trestle along Wasi Road, the Wasi River was investigated along this section of meandering floodplain. No significant signs of erosion were found up to the bridge on the Callandar Bay road. There were some undercut banks and a few places where animals were frequenting the shoreline. I noticed a strong oily odour as soon as near the bridge over hwy 11. At location 58, there is a peculiar seepage coming from the bank on the north side of the Wasi River.

Monitor the seepage at location 58.

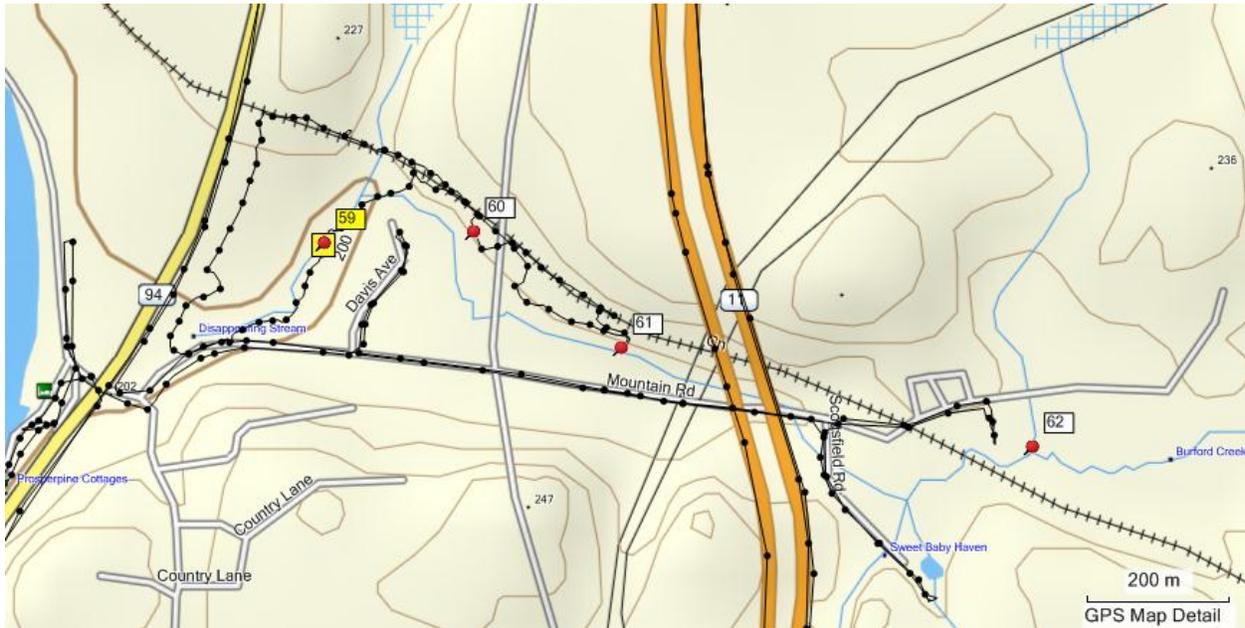
Nov 15-2

Burford Creek was investigated from Mountain Road. Walking up Burford Creek near hwy 11, there was a lot of erosion of the creek banks behind the housing development near location 59 on Davis Ave. Where the creek came under the highway at location 61, it had well vegetated banks and a natural course. On the east side of the highway, there didn't appear to be any significant erosion.

Stabilizing the banks in certain spots along the creek could reduce the loss of soil and potential for phosphorus from residential activities.

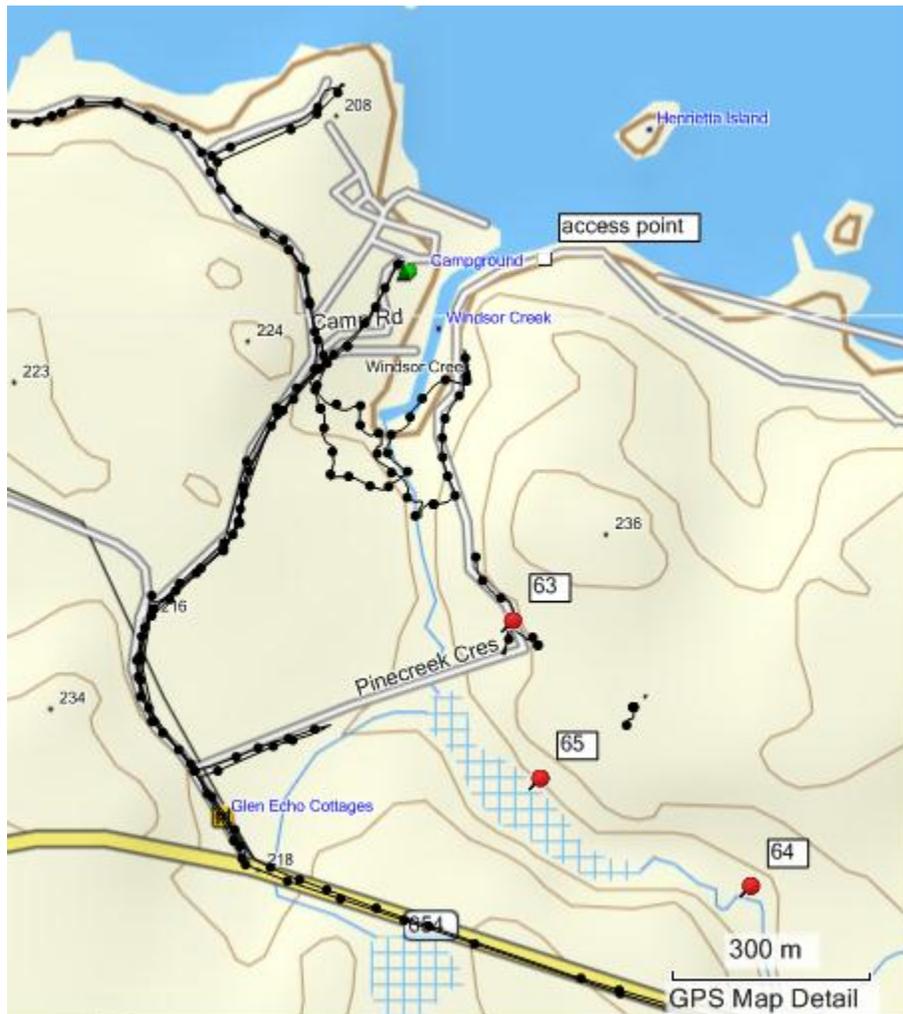
Dec 3-1

The horse paddock on Windsor Creek was accessed from Pinecreek Road North, as shown on the map. Significant erosion was seen near the bridge that crosses the Windsor Creek at location 63. Upstream at locations 64 and 65, Windsor Creek was well vegetated and had a natural course.

Proper fencing to keep livestock out of the creek and re-establishment of native vegetation along the banks will help to keep direct and indirect sources of phosphorus from entering the water column.

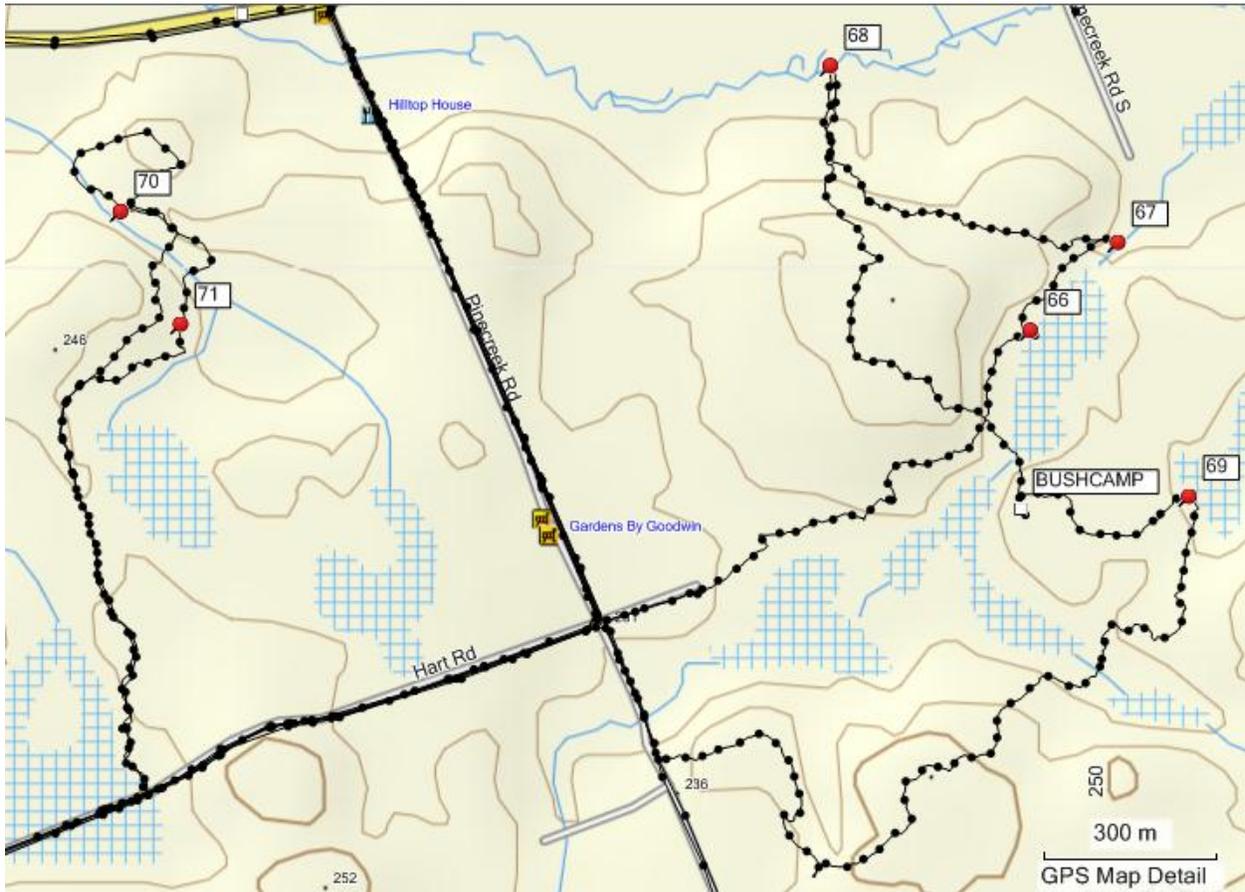
Dec 12-1

In an effort to find the source of significant phosphorus loading in Windsor Creek at the highway 654 bridge as signified by the data, some fairly inaccessible areas were investigated. The area to the east of Pinecreek and Soul Roads has no road access except for the snowmobile trail. On snowshoes, it was possible to walk along the wetland areas without getting wet. There are fields around the hunt camp in this area, but, no evidence of any direct creek degradation leading to the release of phosphorus. The creek that feeds into Windsor Creek from the highlands at Hart Road, was investigated on snowshoes, north, to locations 70 and 71, without any significant evidence of erosion being found.

Since there are a considerable number of blinds in the area of locations 66-69, and a significant number of users apparent, it might be worthwhile to check how the camp and visitors to the area deal with the waste water from the camp.
